ADAMS-FRIENDSHIP AREA SCHOOL DISTRICT

Re: Adams-Friendship Area School District Study

FACILITY STUDY FOR
Adams-Friendship Area School District

Adams-Friendship Elementary School

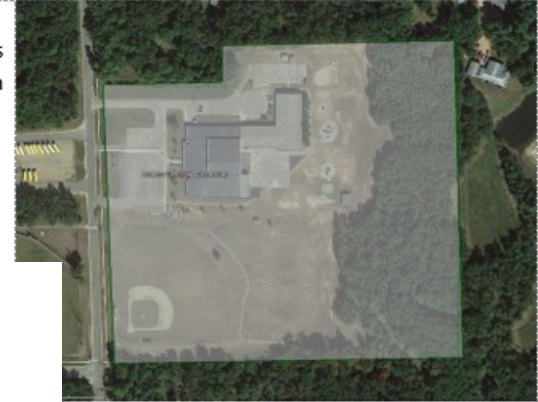
- The site for Adams-Friendship Elementary School is approximately 22.9 acres of athletic fields, open green space, playground space, and some wooded area.

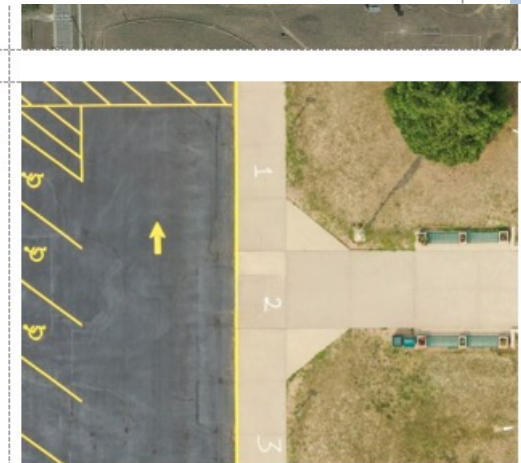
- Generally, the site is appropriately drained for stormwater runoff; however, one playground is noted for collecting water at

- The site has appropriate curb cuts and accessible pathways. Because of the site's reasonably flat nature, no ramps or stair structures are required for access.

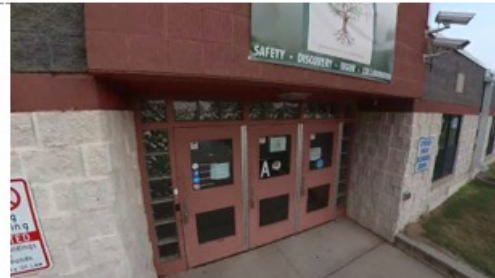
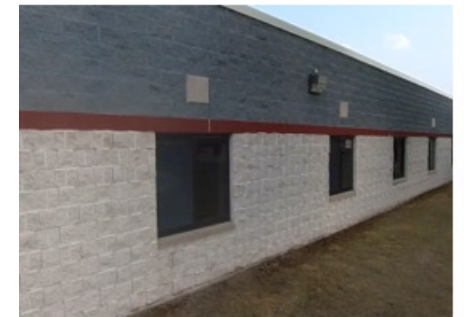
- Exterior doors allow for efficient entry and exit for arrival/dismissal and recess purposes.
- Entrances are minimally sheltered from the sun and weather.

- Most doors are in good working condition, free of deterioration.
- The main entry door has some rusting evident, and the paint has faded significantly. Consider repairing or even replacing the door and frame.

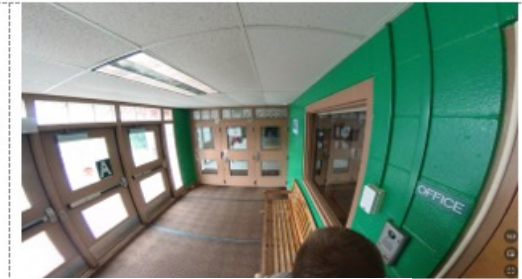
- The building does have a secure vestibule sequence that directs visitors into the office prior to releasing them into the school. The visibility of the approach to the front door is limited.

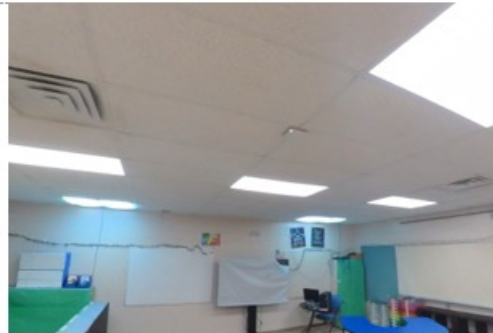
- Classroom ceilings are in good condition but are showing signs of sagging.

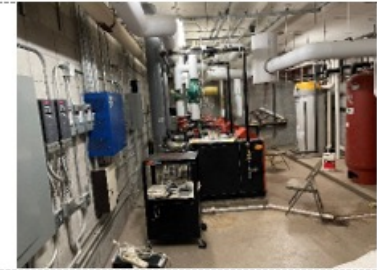
The building has a single heating plant which was upgraded in 2020.

- (3) Thermal Solutions condensing boilers
 - In good condition
 - Average service life is 20 years
- Boiler circulation pumps are provided as part of each boiler
 - In good condition
 - Manufactured by Taco
 - Pumps are constant volume
 - In good condition
 - Average service life on inline pumps is 10 years
- Main heating water pumps are variable speed pumps
 - (2) pumps manufactured by Taco
 - In good condition

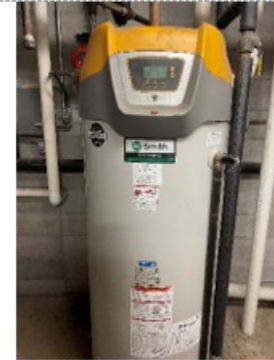
- ✓ The water heaters and circulation pump were replaced in 2013 and are in good condition.
 - Average service life is 20 years.
